DDASaccident313

DDAS Accident Report

Report date: 19/05/2006	Accident number: 313
Accident time: 10:20	Accident Date: 07/07/2000
Where it occurred: Lurio River Bridge, (Cabo Delgado)	Country: Mozambique
Primary cause: Field control inadequacy (?)	Secondary cause: Inadequate equipment (?)
Class: Excavation accident	Date of main report: 08/07/2000
ID original source: GZ/AVS2001:MZ02	Name of source: HT (field): IND 133
Organisation: Name removed	
Mine/device: PMN AP blast	Ground condition: bridge and surrounds metal scrap route (verge) trees
Date record created: 20/02/2004	Date last modified: 29/02/2004
No of victims: 1	No of documents: 1

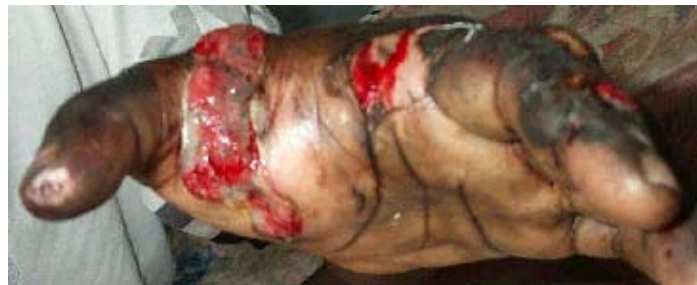
Injuries to the deminer's lower face were caused by the pieces of visor which he had been wearing in the correct manner. The injuries to his left hand were caused by the shattered wooden handle of his enxada which he was using to excavate with. A small point of contention is that the original accident report stated that the casualty had sustained injuries to his right hand rather than those actually to his left. Minor cuts and grazing to his left ankle and upper right arm were caused by secondary fragmentation (soil and stones) from the blast effect of the mine.

The photograph of the victim's hand shown above was made available.

The victim suffered minor cuts and abrasions to the face and damage to his hand, leg and arm.

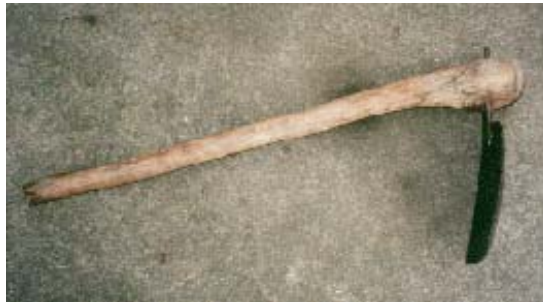
The detector in use was not suitable for use in mineralised soil (as recognized by the decision to use ground-compensating detectors in the internal report) and the quality of the enxada was poor because it broke up in the accident.

A photograph of an enxada is shown above. Locally made, the quality of steel and handle is very variable.

While the use of the tool may be accepted, the quality of the tool being used was clearly inadequate. Hardened steels will crack and shatter in a blast, which appears to have happened in this case. If the blade and the handle were made as one using a medium grade of steel, the tool would be far less likely to shatter and cause injuries – as it apparently did in this case.
